Request to Address Executive Committee to Regarding Sidewalk

Replacement

Department of Engineering Services

May 18, 2018

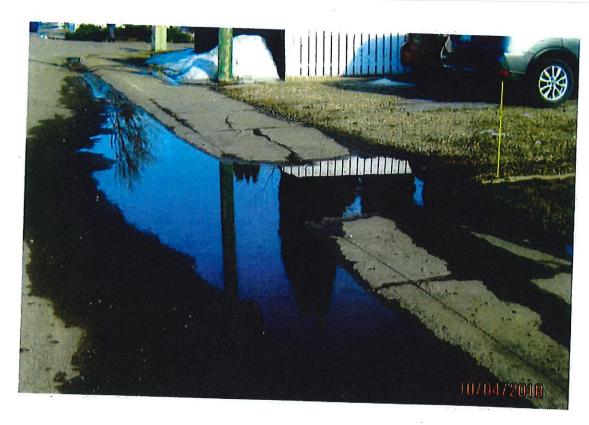
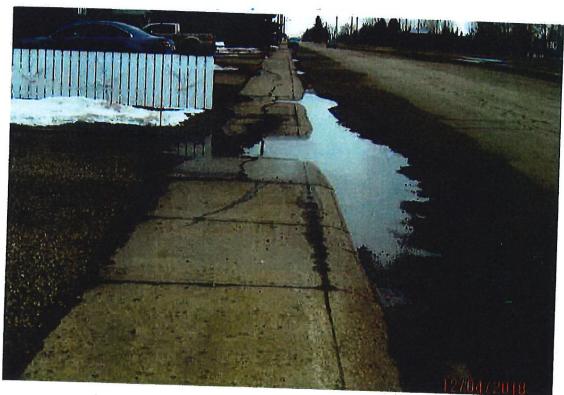
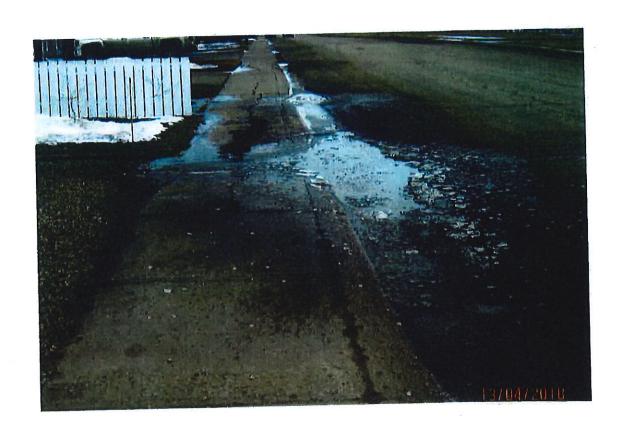
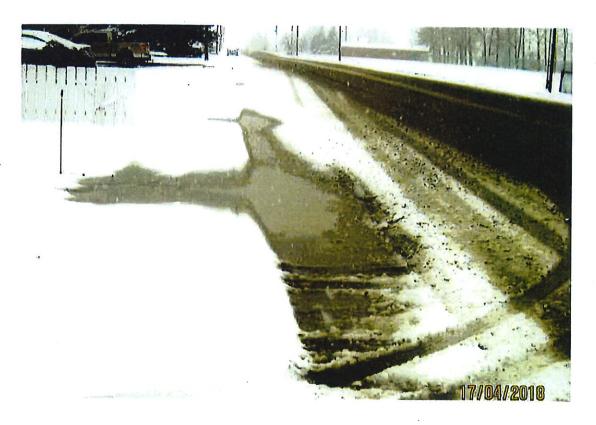
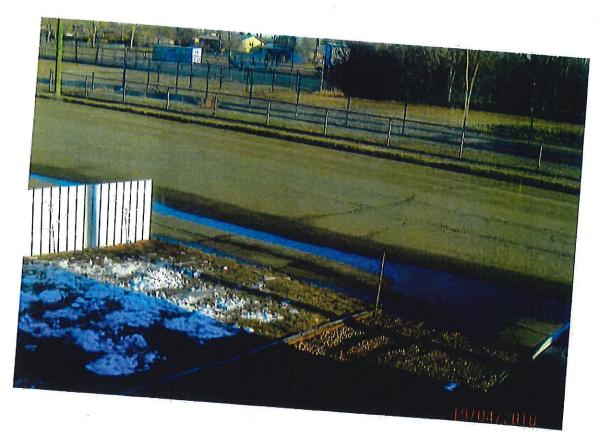
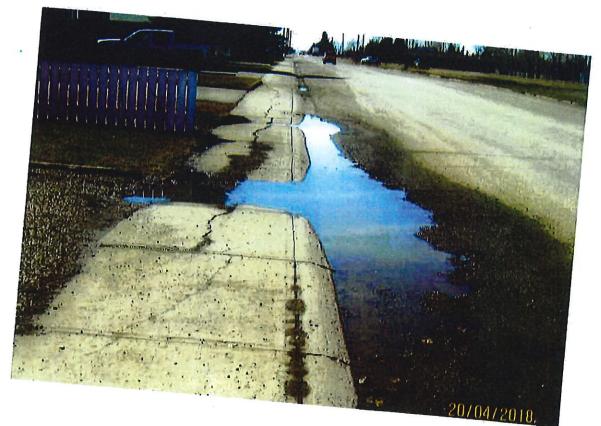
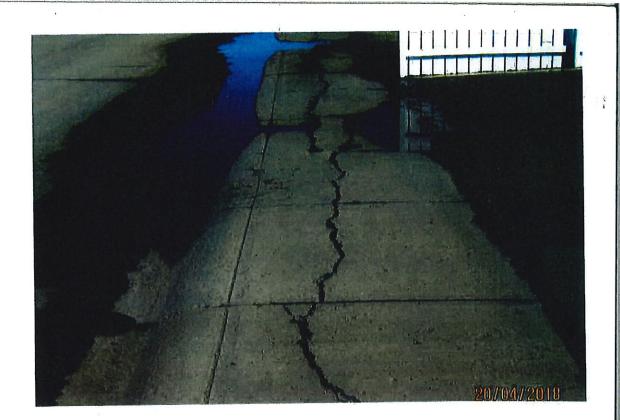
ATTACHMENT #2

A tech assessed the site and the Municipal Operations Manager called Mr. Christmann on May 4, 2018 to discuss. Mr. Christmann's main concern was that the sidewalk had slumped allowing water to pool on the sidewalk during wet weather conditions. Mr. Christmann was informed that while this was a defect in the sidewalk, it was not severe enough to warrant replacement under the current sidewalk, curb and gutter repair and replacement program.

The sidewalk in front of 1507 Caribou St. W. has slumped over the original water and sewer connection installed on Nov. 2, 1978. Slumping is generally not considered a major defect provided the joint between slabs has not experienced severe separation. This sidewalk also has some longitudinal cracking in the area of the slump (see attached pictures). The cracking has offset up to approximately 1/2". Given that the crack runs parallel to the direction of foot traffic, the trip hazard is reduced; however the crack issue specifically will be addressed this year through the operational sidewalk maintenance program. The condition at this location was not severe enough to warrant further intervention when compared to the rest of the City's sidewalk infrastructure.

Remove and replace the existing sidewalk, curb and gutter in front of 1507 Caribou St. W. at a cost of approximately \$3,000 - \$4,000.

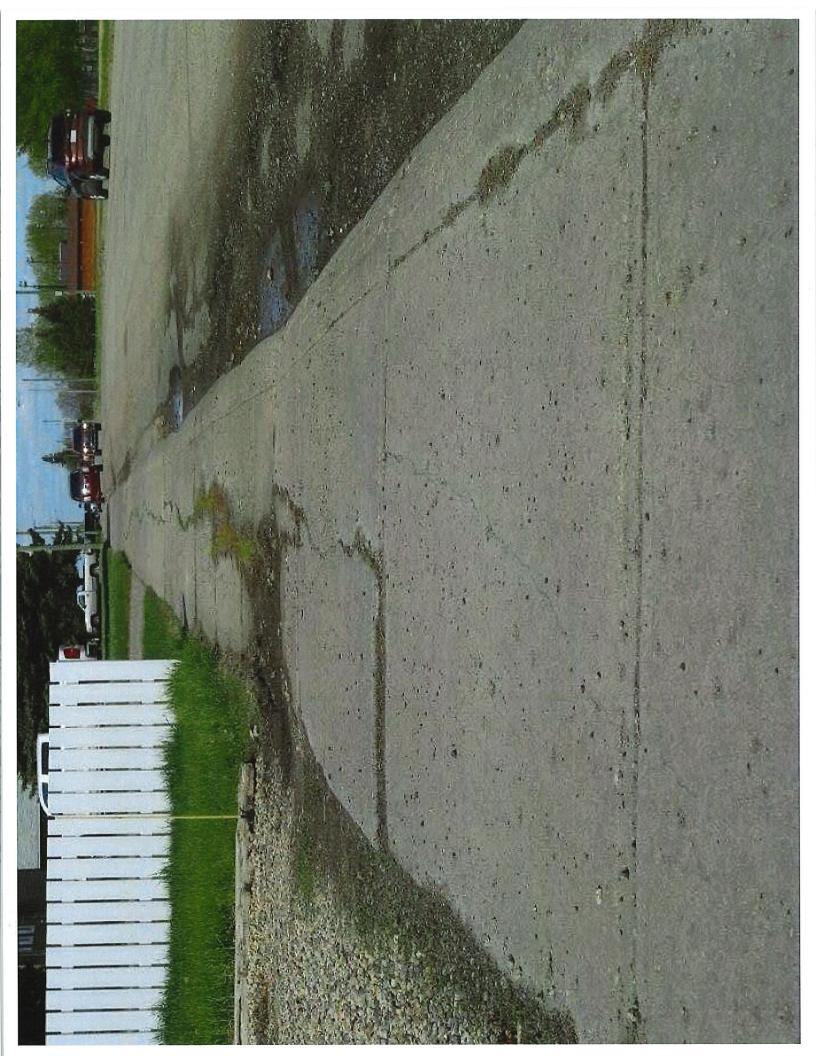
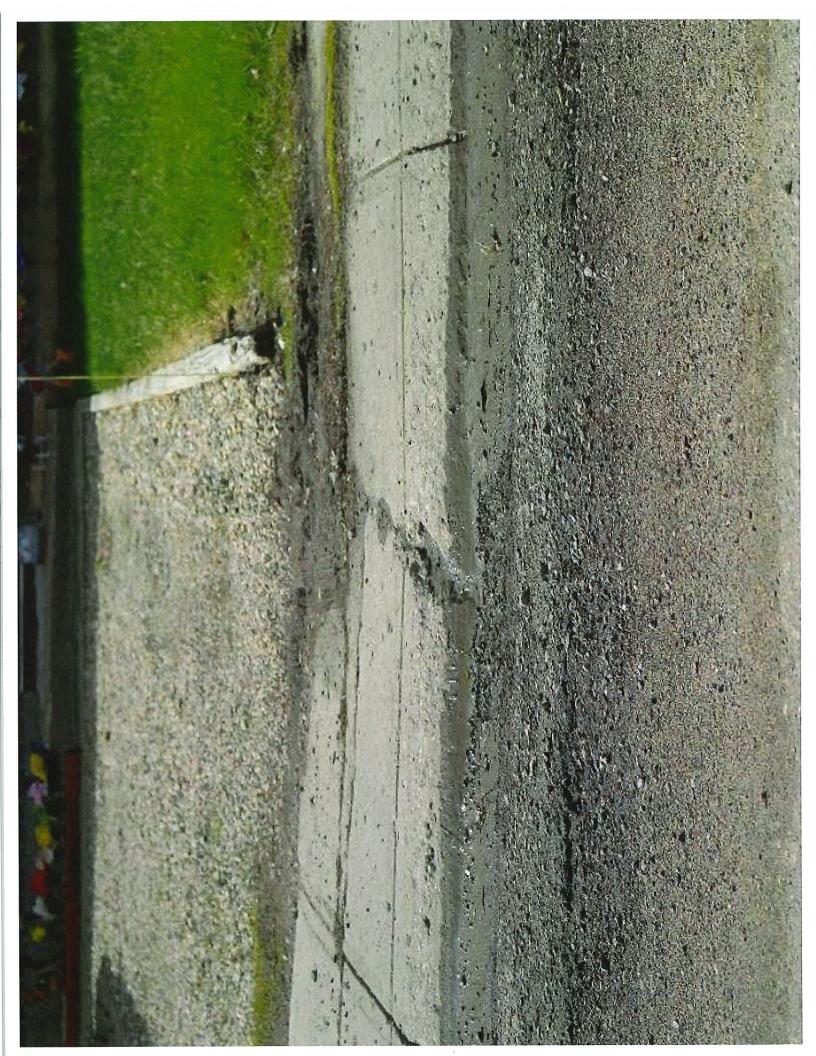
· · · · · · · · · · · · · · · · · · ·
april 26 2018
1507 Caribon St. W Moose Jan.
TO: MEMBERS OF CITY COURSE
Repair sidewalk because its to
Repair sidewalk because its to low several inches of water set on top.
It sidewalk was fixed then hole
on street could be fixed and
on street could be fixed and water could men last.
The water is seasing in the ground
The water is seaping in the ground. I'm worried that water well go in our basement.
in our basement.
This problem was here before we
bought the house.
Getting tired of droing our Can in this water hold.
in this water hold.
RAYCHVISTMANN
1507 Caribou St. W.
693-0796
