Iron Bridge – Design Improvements

West Berm

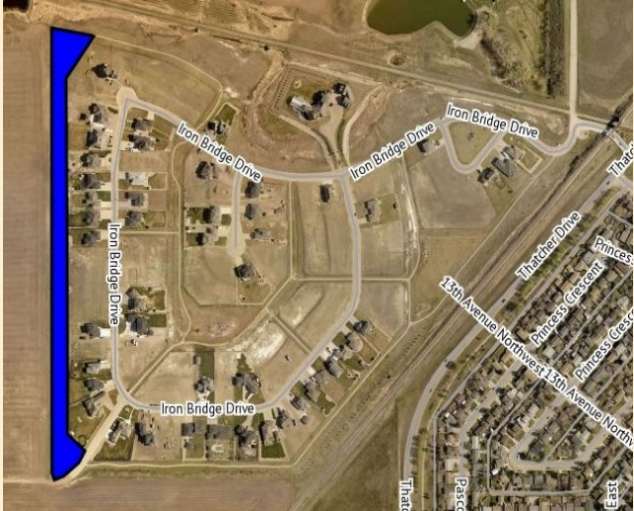
Deficiencies & Maintenance Issues	Budget Estimate																				
<ul style="list-style-type: none"> ▪ Can only access trees with water truck from pathway which causes damage to asphalt ▪ Trees exposed to pesticides from adjacent field ▪ Trees on top of berm have difficulty retaining water ▪ Tree spacing makes it extremely difficult to mow ▪ Can only access berm with mower in dry conditions ▪ Large presence of thistle, dandelions, and foxtail due to proper turf never being established ▪ Significant gopher presence on berm which is affecting tree health and intrusion on adjacent properties

Recommended Improvements	Location																				
<ul style="list-style-type: none"> ▪ Remove all dead Colorado Spruce and transplant healthy trees to other locations (plant in groupings to promote ease of mowing) ▪ Replace berm trees with drought-tolerant species such as Caragana to create shelter belt ▪ Spray, strip and remove all existing vegetation ▪ Complete soil tests, add topsoil and re-grade as necessary ▪ Hydromulch with drought tolerant dryland naturalized grass mix and fertilizer ▪ Install temporary irrigation using existing turf valves until turf is fully established ▪ Install temporary drip lines for new trees using existing turf valves ▪ Add environmental reserve signage

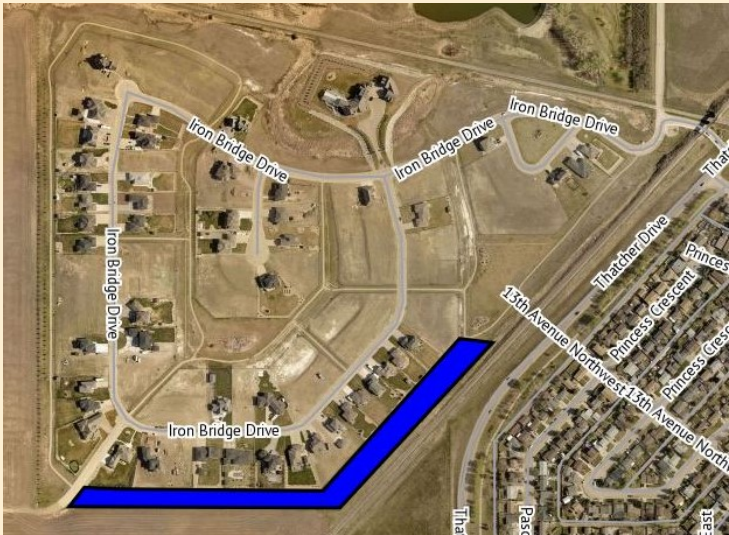
South Berm

Deficiencies & Maintenance Issues	Budget Estimate																		
<ul style="list-style-type: none"> ▪ Can only access trees with water truck from pathway which causes damage to asphalt ▪ Trees exposed to pesticides from adjacent field ▪ Trees on top of berm have difficulty retaining water ▪ Tree spacing makes it extremely difficult to mow ▪ Can only access berm with mower in dry conditions ▪ Large presence of thistle, dandelions, and foxtail due to proper turf never being established ▪ Significant gopher presence on berm which is affecting tree health and intrusion on adjacent properties

Recommended Improvements	Location																		
<ul style="list-style-type: none"> ▪ Remove all dead Colorado Spruce and transplant healthy trees to other locations (plant in groupings to promote ease of mowing) ▪ Spray, strip and remove all existing vegetation ▪ Complete soil tests, add topsoil and re-grade as necessary ▪ Hydromulch with drought tolerant dryland naturalized grass mix and fertilizer ▪ Install temporary irrigation using existing turf valves until turf is fully established ▪ Install temporary drip lines for new trees using existing turf valves

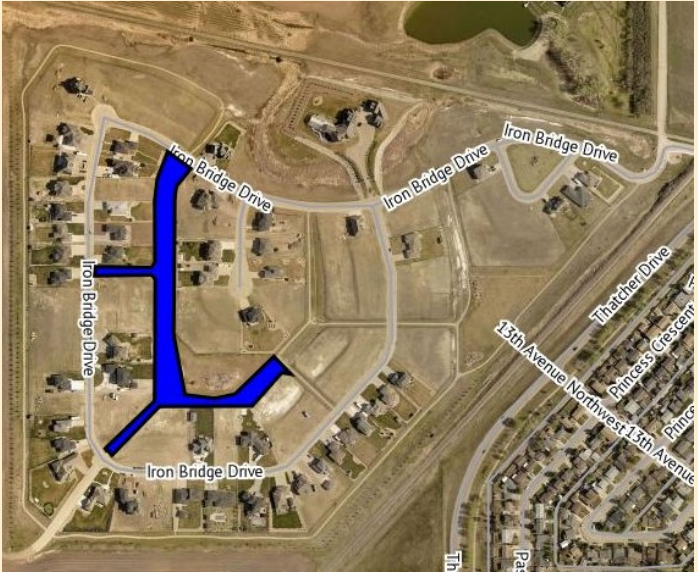
West Municipal Reserve

Deficiencies & Maintenance Issues	Budget Estimate																		
<ul style="list-style-type: none"> ▪ Cannot establish healthy turf due to soil quality and lack of irrigation ▪ Large presence of broadleaf weeds and foxtail ▪ Design of drainage swales makes swales difficult to maintain – cannot mow many areas in wet years

Recommended Improvements	Location																		
<ul style="list-style-type: none"> ▪ Expand irrigation system to non-swale areas ▪ Spray, strip and remove all existing vegetation ▪ Complete soil tests, add topsoil and grade as necessary ▪ Hydromulch with salt tolerant playground mix in irrigated areas and drought tolerant dryland naturalized grass mix in non-irrigated areas

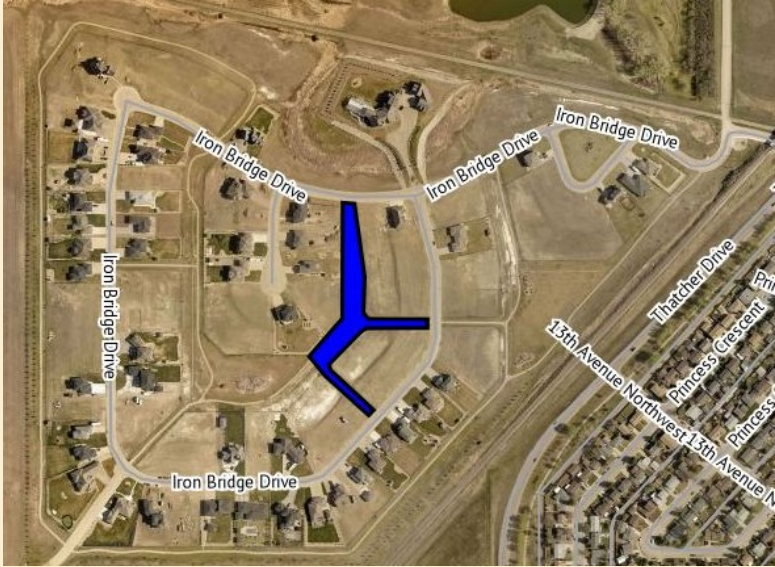
Central Municipal Reserve

Deficiencies & Maintenance Issues	Budget Estimate																		
<ul style="list-style-type: none"> ▪ Cannot establish healthy turf due to soil quality and lack of irrigation ▪ Large presence of broadleaf weeds and foxtail ▪ Design of drainage swales makes swales difficult to maintain – cannot mow many areas in wet years

Recommended Improvements	Location																		
<ul style="list-style-type: none"> ▪ Expand irrigation system to non-swale areas ▪ Spray, strip and remove all existing vegetation ▪ Complete soil tests, add topsoil and grade as necessary ▪ Hydromulch with salt tolerant playground mix in irrigated areas and drought tolerant dryland naturalized grass mix in non-irrigated areas

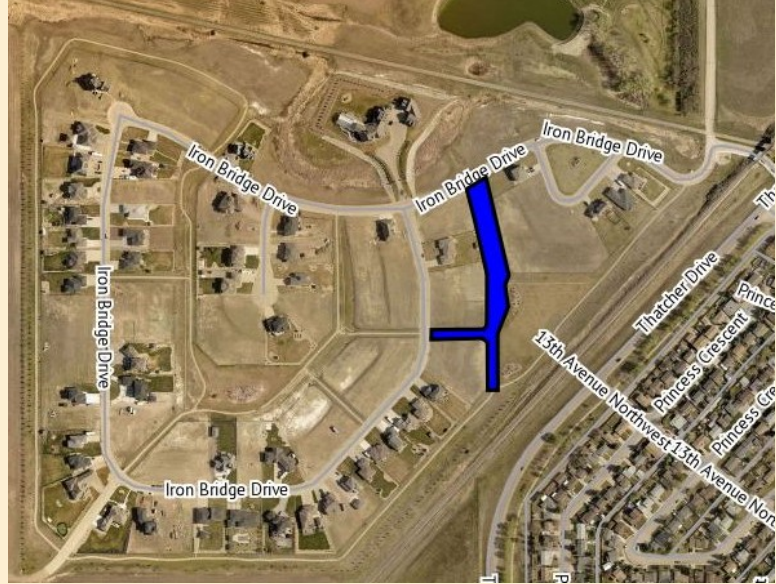
East Municipal Reserve

Deficiencies & Maintenance Issues	Budget Estimate																
<ul style="list-style-type: none"> ▪ Cannot establish healthy turf due to soil quality and lack of irrigation ▪ Large presence of broadleaf weeds and foxtail ▪ Design of drainage swales makes swales difficult to maintain – cannot mow many areas in wet years

Recommended Improvements	Location																
<ul style="list-style-type: none"> ▪ Expand irrigation system to non-swale areas ▪ Spray, strip and remove all existing vegetation ▪ Complete soil tests, add topsoil and grade as necessary ▪ Hydromulch with salt tolerant playground mix in irrigated areas and drought tolerant dryland naturalized grass mix in non-irrigated areas
